Repair of Major Road Embankment Failure Using Reinforced Earth (re) wall

A case history of repair works of major road embankment failure along Genting Highlands to Bukit Cincin, Pahang is presented. Failures at 10 locations along Genting Highlands to Bukit Cincin road occurred on 30th October 1997 during the monsoon seasons. The repair works at Location 1 using reinforced earth wall was considered since there was enough space available at the downslope section and also the soil at the downslope section of the failed embankment was strong enough to construct the wall safely. This paper fully explained the details remedial works using reinforced earth wall at Location 1.

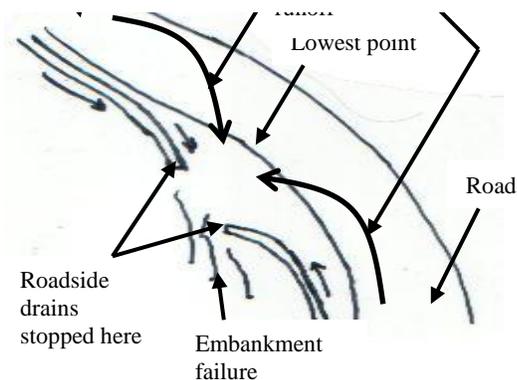
The causes of failure for this embankment were predominantly due to (a) soil erosion since roadside drains were not connected to cascading drain to lead rain water and surface runoff to the toe of slope and (b) improper compaction of the fill material resulting in critical battering of the slope. Erosion caused the toe of slope to progressively fail. Figure 3 shows erosion causing the major road failure while Figure 4 shows the failure at Location 1.

Fig. 3 : No cascading drains causing erosion which lead to embankment failure.

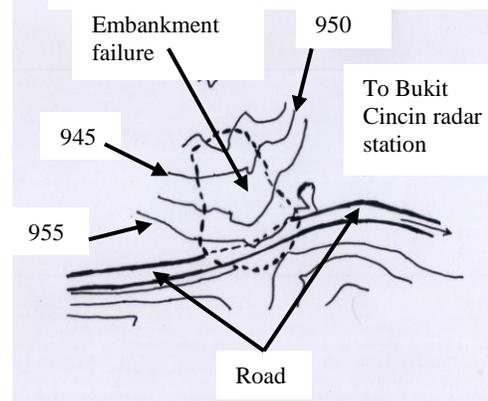
The road embankment was totally collapsed and was impassable to vehicles. The existing pavement, drains as well as gabion stabilizing and supporting the embankment at its toe also collapsed. Temporary access was carried out by Genting Berhad by dumping soil on the failed embankment so that vehicles can pass through the failed road.

Fig. 4 : Road embankment failure at Location 1.

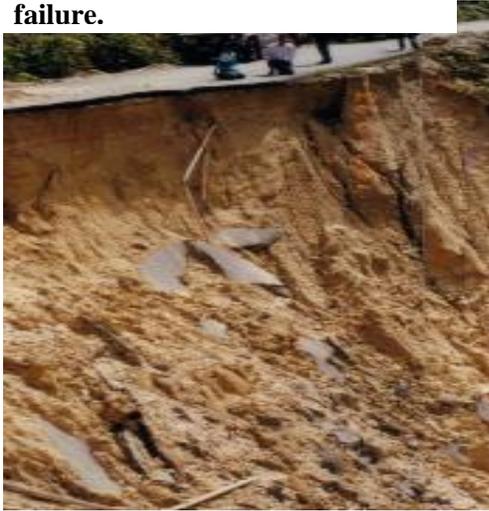
The shallow slips retrogressively moved towards the crest of the embankment created instability to the embankment. As this phenomena proceed, slumping of soil mass occurred and forming a vertical scarp at the crest of the embankment as described by Bumi Hiway (1998). Figures 5 and 6 show the road embankment failure.

Fig. 5 : Major road embankment failure.

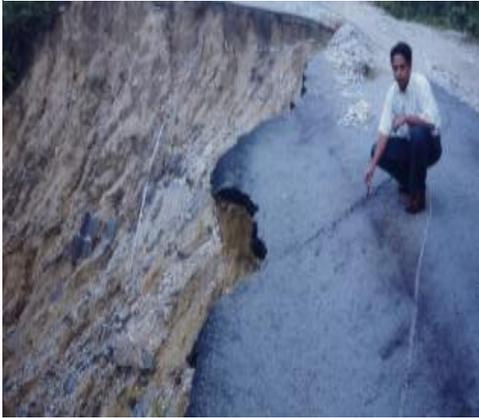
Fig. 6 : Another view of the road embankment failure. The road was totally impassable to vehicles.

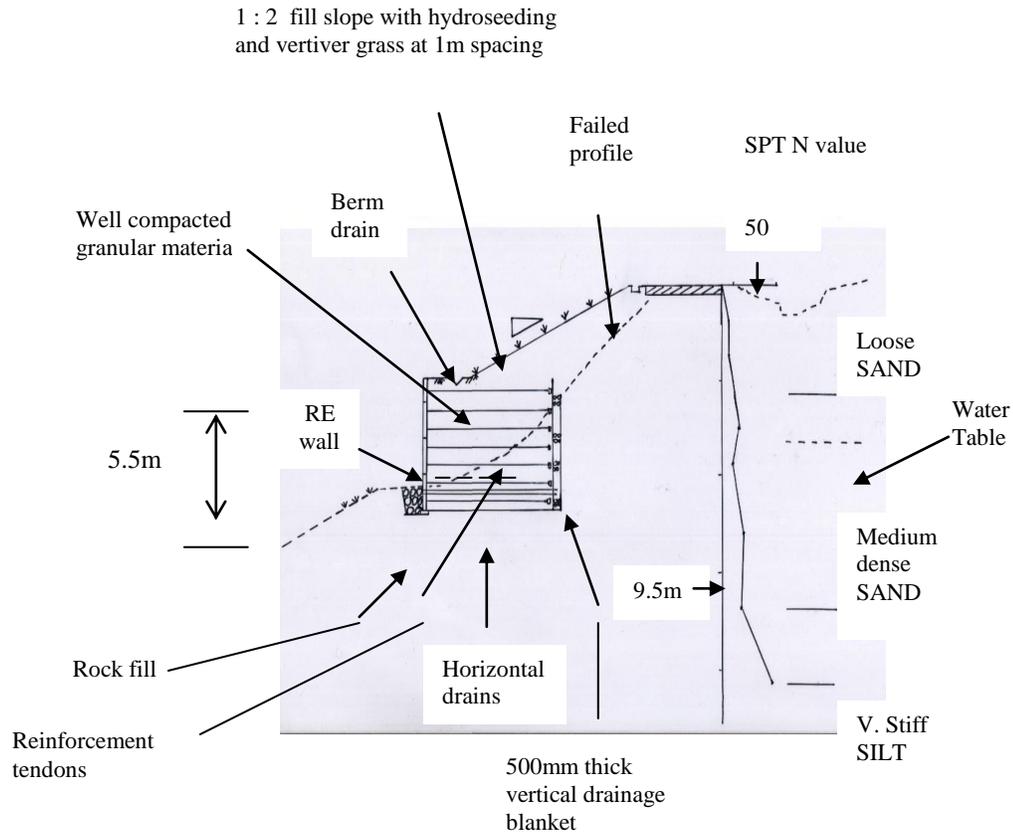
Reinforced earth wall was suitable and used as the repair works for the failed embankment since the soil to place the wall was strong and also enough space was available to place the wall safely as recommended by Neoh et al. (1997). The base of the wall was decided at 9.5m below the existing road level. From BH/1, at this level, the soil type was medium dense clayey SAND with SPT N value of 9.

Fig. 8 : Typical cross section of the repair works and the results of BH/1.

The wall height was 5.5m by 5.9m wide and about 29m long. Figure 7 shows the plan view of the repaired zone while the typical cross section of the repair works and the results of BH/1 are shown in Figure 8.
