## **TECHNICAL NOTE**

### **ENGINEERING GEOLOGICAL OF AN ACTIVE SLOPE IN KM46 SIMPANG PULAI, PERAK**

**Zainuddin Md Yusoff\*, Nur Anati Azmi, Haslinda Nahazanan, Nik  
Norsyahariati Nik Daud & Azlan Abd Aziz**

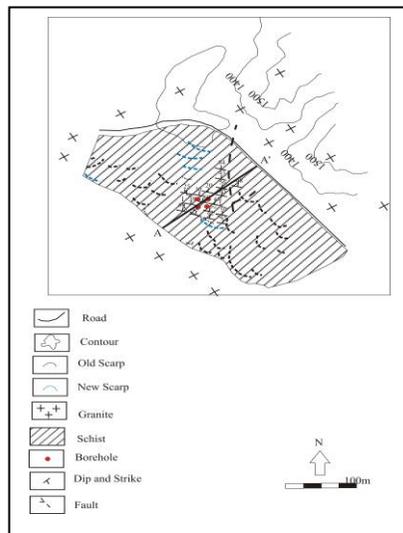
The topography of the research area can be classified as terrain or hilly based on the elevation the surround area ranging between 1300m until 1700m. The research area situated nearby a hill named Gunung Pass with its highest peak at 1507m. The research area had a slope considered as unstable. Concrete foundations were ripped away from the slope. There were a few of old scarps and new scarps detected (Fig. 2.).The largest scarp was 10.5 m width and located at height of 12m from road. The existence of high number of scarps, can lead to the high possibility of sliding to be activated and another slope failure should occur in the near future.

Figure 2: Engineering geological map of slope KM 46 Simpang Pulai-Cameron road

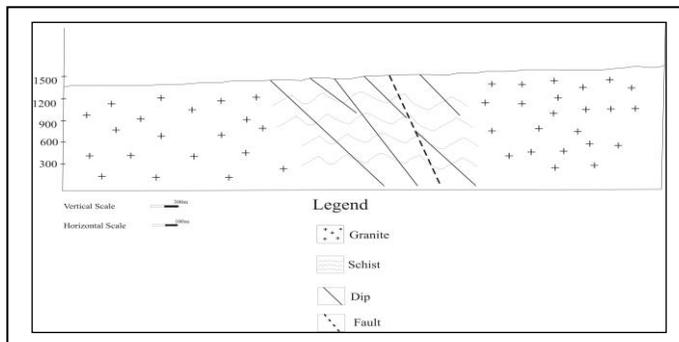
Geological structure can occur from tectonic activities. The most prominent geological structures that can be identified from engineering geological cross section in Fig.3 is the fault structure. There is one major fault nearby the research area. The fault orientation is oriented to the Northwest direction same orientation with dip direction of slope dip. This situation will cause failure for the slope. Stereographic analysis for the fault also shows there is wedge failure detected because the intersection lines of major planes falls at unstable area Fig. 4. There were also few old scarps and new scarps detected

Figure 3: Engineering geological cross section

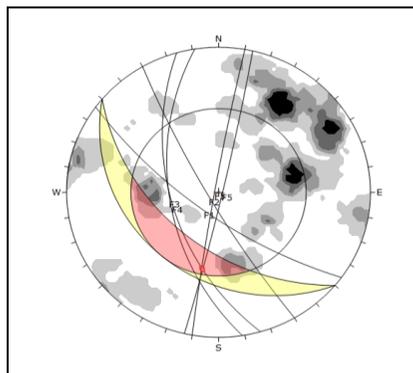
Figure 4: Fault stereographic analysis

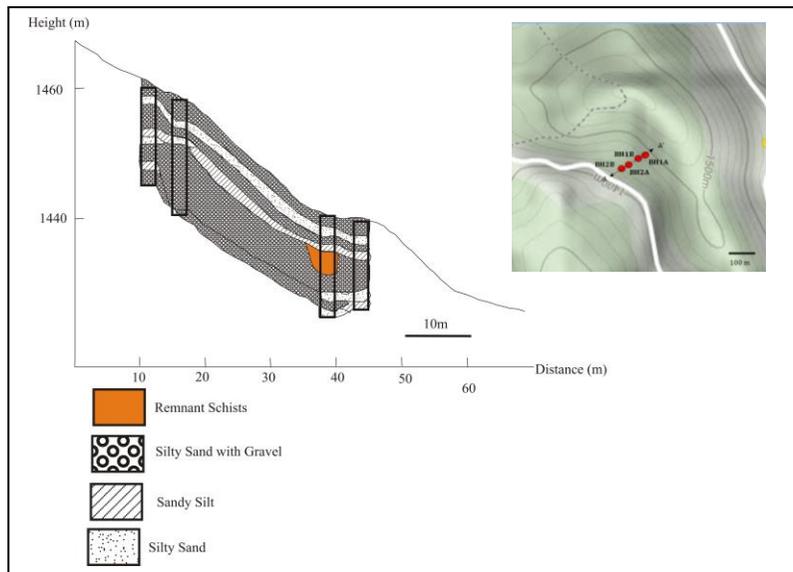
A hard layer is defined as SPT  $N=50$  blows. In borehole 1A, the hard layer was encountered at 15m below ground level, 15.5m for borehole 1B, 15m for borehole 2A and 13.5m for borehole 2B. The holes were terminated after 3 times  $N=50$  blows which represents 4.5m thick hard layers. From the laboratory test, the materials forming the residual soils are sandy SILT to silty SAND. Three units type of soil were recognized as distinct geotechnical units which were sandy silt, very silty very gravelly sand and fragments of schist. The sandy silt unit consists of light grayish, dark yellowish, light yellowish to dark brownish colour with mixtures of sand and silt. The SPT value range from  $N=5$  to 50. The hardness varied from very soft to hard. The percentage of silt was more than 50% and sand is 20% to 35%. The very silty very gravelly sand unit varied from dark grayish to dark brownish colour. This unit composes mixture of sand, silt and gravel. The average composition for this unit was more than 50% is sand, 20% to 35% is silt and another percentage was gravel. The hardness of this unit was from very loose to very dense. Cross section from boreholes results (Fig.6) shows there were movement in BH2A and BH2B and this situation can be classified as shear zone. This showed that there was deep seated movement at great depths. However, the movement was very slow and will increase during rainy seasons. Another factor identified from the profile (Fig.6) was the existence of schist fragments that contribute to the infiltration of water, thus, allow rapid rate of weathering and produce unstable materials.

Figure 6: Borehole profile cross section
