TECHNICAL NOTE

**RISK FACTOR IDENTIFICATION IN THE
MANUFACTURING PROCESS OF HOLLOW CORE SLAB**

4.1 Fabrication Process of HCS

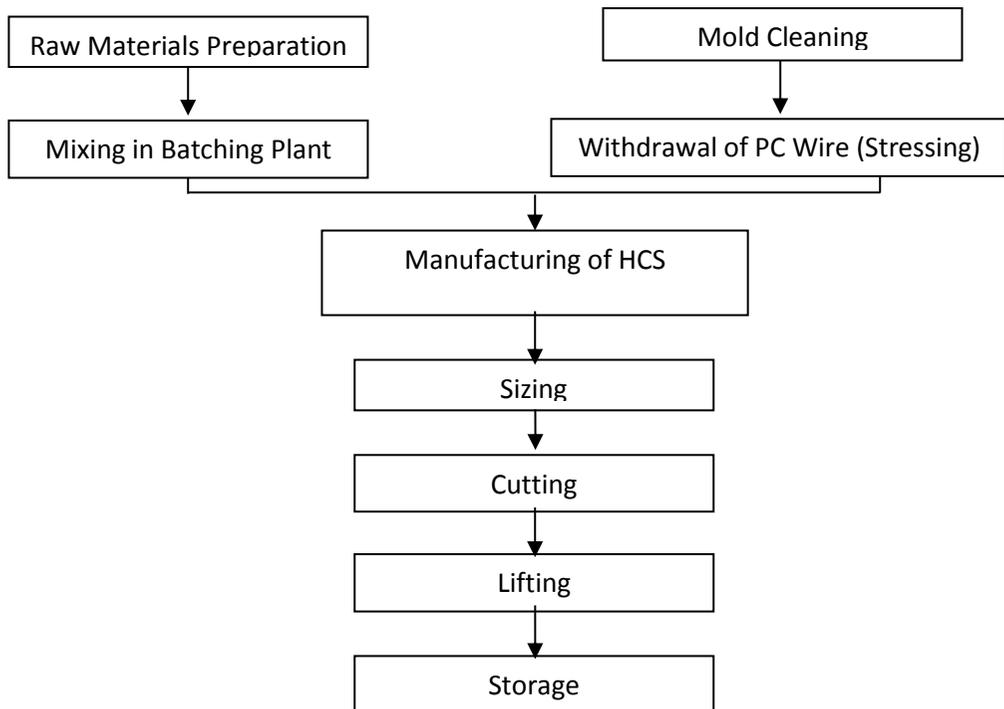
Hollow Core Slab (HCS) is a building material in the form of precast hollow floor plate, in the width of 1.2 m and the length based on consumer request. The path length of HCS in this research is 150 m. The fabrication process of HCS can be seen in Figure 1 below. From each activity of the fabrication process in Figure 1, identification and analysis are conducted so it can produce risk factors that are related to the stages of the process. Identification is conducted by using expert opinion method by an interview to every head of division that involved and direct observation method.

Figure 1: Fabrication process scheme of HCS

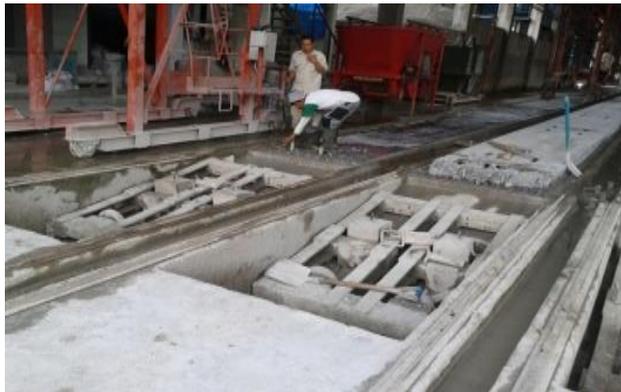
Based on the field observation, the operator did not use gloves when using putty knife, where there is a possibility that the operator's hand wounded when using putty knife or while taking the remnants of concrete piece (Figure 2). If this thing happened there are first-aid boxes around the site work that can be used to treat wounds in hand.

Figure 2: Operator cleaned the mould without using gloves

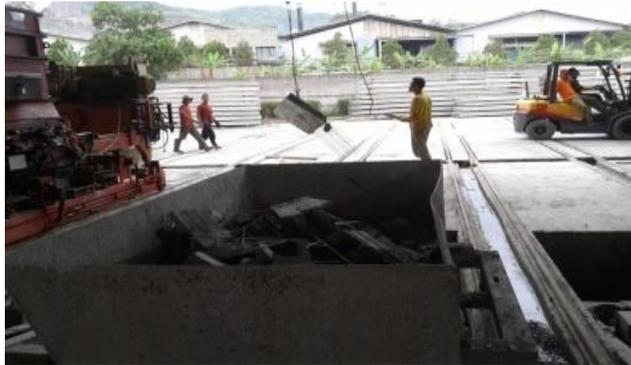
After the manufacturing process of HCS, the operator cleaned again the mold by removing 50-cm concrete remnants from the end of the lane by using a hoist. This process is also assisted by an operator who directed the concrete remnants to the disposal site. Based on the field observation the operator did not use safety devices such as helmet and gloves to protect his body from the wire that comes from the concrete (Figure 3). If this thing happened, this can cause injury to the hand, head and other body parts.

Figure 3: Operator directed the concrete remnants without using safety devices

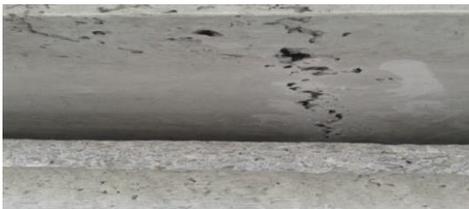
Tearing defect occur if at the time of manufacturing process of HCS, the concrete dragged down by slide former machine that caused the concrete ripped (Figure 4). If there is a small size of tearing, then the concrete can be repaired by patching. Patching is a repairing method for concrete by embedding bonding agent and cement in the concrete. However, the tearing is too big, then the concrete cannot be used as HCS.

Figure 4: Tearing defect

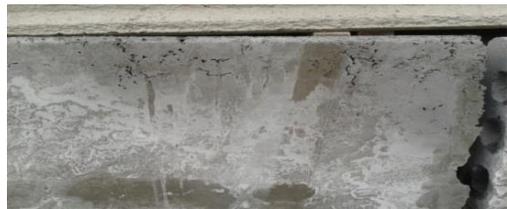
Pore defect is a concrete defect in the shape of small holes in the pores of the concrete (Figure 5). This pore defect has no effect on the structure of HCS, only affecting the aesthetic factor. This pore defect can be repaired by patching.

Figure 5: Pore defect

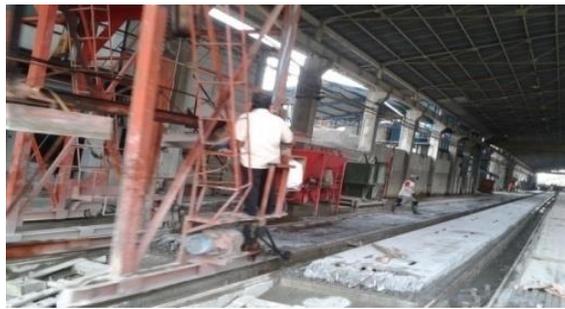
During the lifting process of HCS, the operator operates the lifter in a standing position without using a helmet as shown in Figure 6 where there are lifter components around

him which can be dangerous if the operator's head hit by those components. In fact it is dangerous because it can cause a mild impact like bumps to disorders of the central nervous inside the head that can eventually cause a brain concussion or other nervous disorders.

The operator also did not use safety shoes, but a sandal made of rubber (Figure 6). This is quite dangerous because the operator can just slip or hit by the machine components when operating the lifter. Based on the interview with the Chief of the General Division, work accident due to fall off from lifter can seriously harm the operator and may cause fatality.

Figure 6: Lifter operator did not use helmet and safety shoes

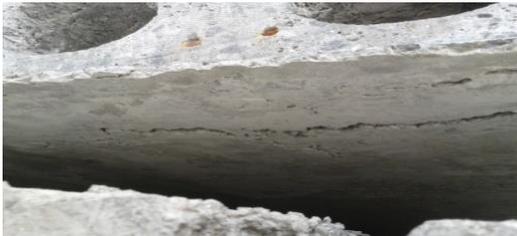
Crack in HCS may occur in the lifting process if the HCS released from the lifter (Figure 7). If there is a crack that is long enough then the HCS cannot be used. If the crack is not long then HCS will be cut and stored in stockyard for other projects that require the length of the HCS that has been cut.

Figure 7: Crack in HCS

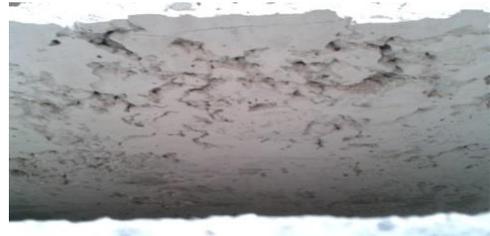
Figure 8: Porous Defect

In the lifting process of HCS, there may be porous defect in concrete if it hit by machine (Figure 8). Non severe porous defect can be repaired by patching.
