# Properties of Traditional Clay Roof Tiles Manufacture in Kelantan, Peninsular Malaysia

*Nor Hidayah Abdullah, Rodiah Zawawi, Zuraini Md Ali  
Department of Building Surveying, Faculty of Built Environment,  
University of Malaya, 50603 Kuala Lumpur, Malaysia  
hidayah5192@hotmail.com*

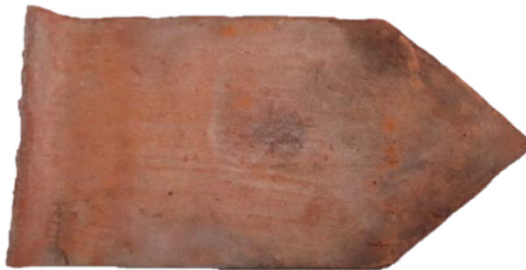
A Singgora tile (Figure 1) is a roof covering for old building which commonly found predominantly in Kelantan and Terengganu. It is become highly important as a roofing material of conservation for repairing, replacing or even reconstructing them totally. It can last for up to 150 years and used traditionally in dwellings, palaces and community centers (Hanafi, 1996). Singgora tiles is the most distinctive and decorative historic roofing materials because of their great features in shape and colour. The colour is pale orange which imparts the natural hue to the building. In terms of aesthetic value, Singgora tiles form a unique look, like fish scales, when arranged in the roof framework (Killmann et al., 1994). Singgora tile has formed a symbol of identity to the Malaysian traditional architecture. One of the famous buildings that used Singgora tiles is Jahar Palace in Kelantan which built in 1887 (Nasir, 1979).

Figure 1: Singgora tiles

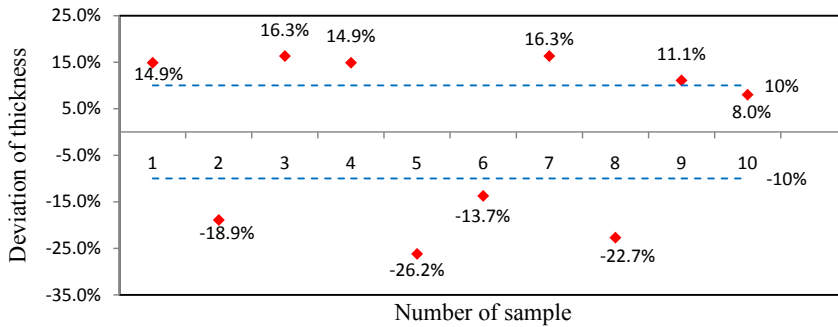
Figure 3 to 5 shows the deviation of length, width, and thickness of Singgora tiles from the mean value. There is no work size of length specified by the manufacturer. Therefore, the average dimension of ten samples, which is a total of 40 measurements, is considered as work size in the experiment.

According to the BS EN 14411:2006 (Annex F), the deviation of length and width of tiles shall fall within  $\pm 2.0\%$  of the work size while the thickness is within  $\pm 10.0\%$ . The work size of length, width and thickness of Singgora tiles are 208.32mm, 163.78mm and 6.75mm respectively. Only 20% of the length and 10 % of thickness are meeting the standard requirement. Overall, although the width of all samples is within the allowable deviation, the samples are considered did not satisfy the standard. The reason of failure is their length and thickness is not fulfilling the minimum requirement of deviation. The variation in the dimensions of green tiles is contributed by the variation size of mould to shape the tiles. In fact, good tiles should be consistent in size and only vary within allowable tolerance to avoid the different joint sizes and to ensure the proper installation and smooth flow of water.

Figure 5: The deviation of thickness from the average value
