CAMPUS WALKABILITY IN MALAYSIAN PUBLIC UNIVERSITIES: A CASE-STUDY OF UNIVERSITI MALAYA

Liow Ken Keat¹, Naziaty Mohd Yaacob² & Nor Rasidah Hashim³

*^{1,2,3} Centre for Sustainable Urban Planning & Real Estate
Faculty of Built Environment
UNIVERSITY OF MALAYA*

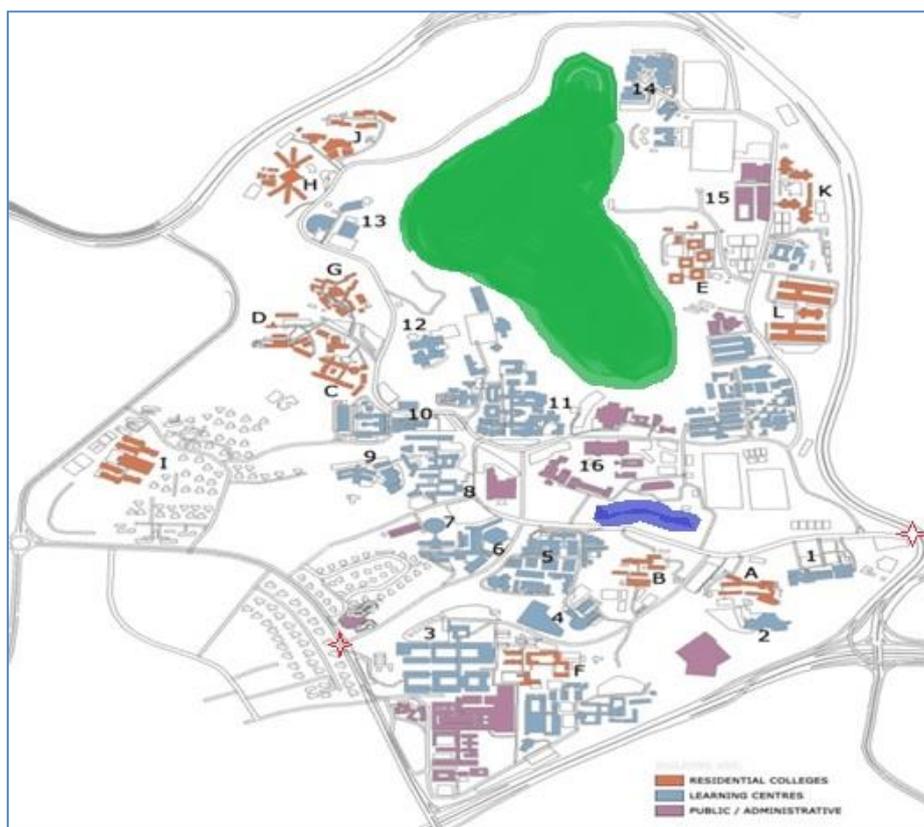
Figure 1: Map of Universiti Malaya campus showing the locations of residential colleges, learning centres (faculties / academies) and administrative buildings. Special features shown are; PJ and KL gates (star), lake (blue) and forested hilly area (green).
Source: Universiti Malaya

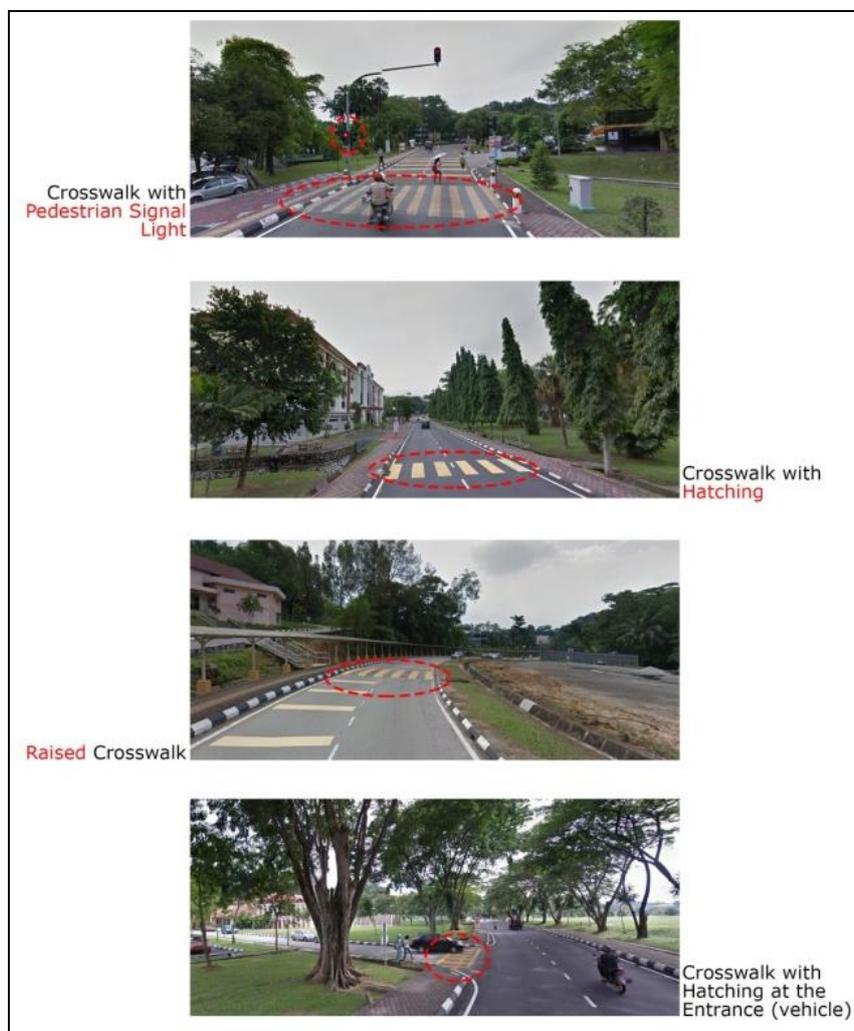
For the pedestrian crossings on campus, we found that there were three types of pedestrian crossings: crosswalk with pedestrian light signal, crosswalk with hatching and raised crosswalk (Figure 2). Crosswalks can be the most dangerous area for pedestrians because of the conflict with vehicular traffic, therefore, well-marked, mid-block and raised crosswalks would assist pedestrians to cross, while the placement of these crosswalks along with a well-planned traffic system and infrastructure will make for safer, secure and comfortable walking experience, with reduced conflicting points.

Figure 2: Types of pedestrian crossings.

Observed and Measured Findings	Suggestions for Improvement
Street Elements within Curb-to-Curb Roadways <ul style="list-style-type: none"> • Pedestrian Crossing • Number of Traffic Lanes • Width of Traffic Zone • Number of Traffic Calming Devices 	With better design such as well-marked crosswalks, mid-block crosswalks, and raised crosswalks can create safe walkways on which pedestrian can cross the road with comfort. Mid-block crosswalks can improve the walkability by providing a better access to areas for pedestrian while limiting the number of pedestrians crossing without a crosswalk. Crosswalk to be placed every 30m. Median should be designed on the traffic zone, which exceeds 2 to 3 lanes so that the protection and resting point can be provided for the pedestrians.
Street Elements within Sidewalk <ul style="list-style-type: none"> • Width of Walking Zone • Width of Utility Zone • Width of Landscape Zone • Sidewalk Surface 	Walking zone should be at least 1.8m - 3.0m wide or greater for higher pedestrian volumes. Trees planted along the edges of roadways and in medians would provide a barrier for pedestrians and also help in slowing down vehicle speeds. Trees would also help to create a more pleasant environment for pedestrians and create the image of the roadways as a part of a place or destination, not just a vehicular route.

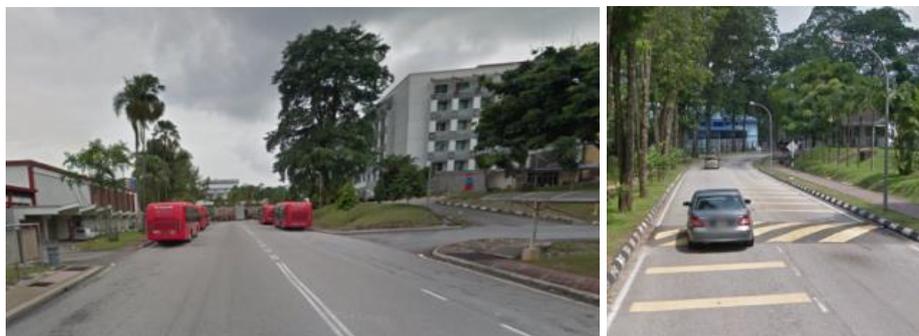
The widths of the traffic zones on campus were found to be in the range of 7m to 14m. The widest traffic zone is at Lingkungan Budi (Figure 3) where the main bus station is located. Referring to Littlefield (2012), the maximum vehicle width permitted is 2.5m, and the minimum clearance between parallel vehicles is 0.5m, hence the minimum lane width is 3m. Our suggestion is to create narrower lanes so as to control vehicle speeds and to shorten crosswalk length.

Figure 3: Lingkungan Budi near UM main library (left) and the speed bump (right).

Additionally, traffic calming devices such as speed bumps, raised crosswalk, and textured paving treatments (Figure 3) can help to slow down traffic especially at the pedestrian crossing area. Pedestrian crossings need to be planned and designed together with the vehicular traffic system, where the design of the pathways, curb and road is based on behaviour of both pedestrians and drivers.

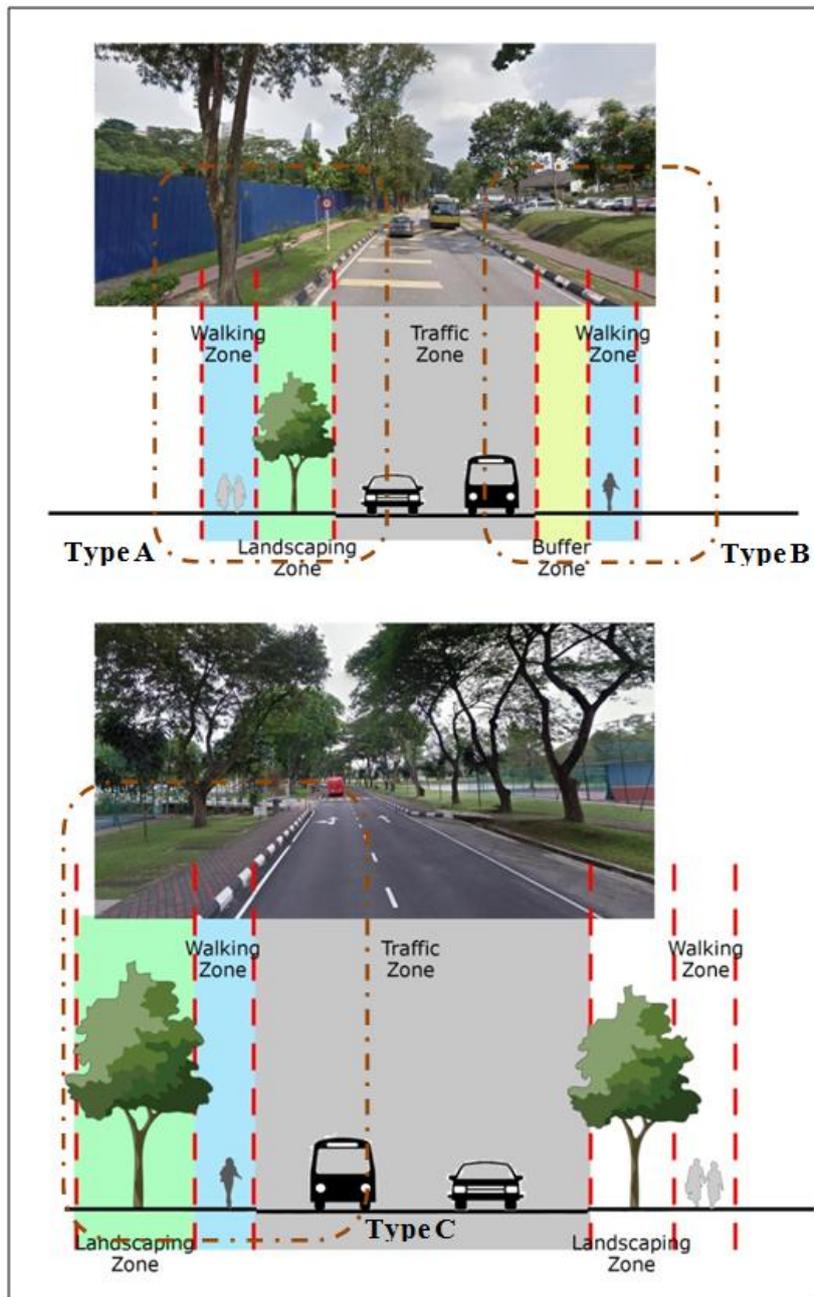
There are three types of pedestrian sidewalks that can be found on UM campus. Type A - landscaping zone in between walking zone and traffic zone, Type B - buffer zone in between walking zone and traffic zone, and Type C - walking zone in between landscaping zone and traffic zone (Figure 4).

Figure 4: Types of pedestrian sidewalks.

As pedestrians spend most of their travel in an area called the walking zone (often located on both sides of a road / street), this zone should be free from all obstacles, protruding objects, and any vertical obstructions hazardous to pedestrians, particularly for individuals with vision impairments. The walking zone should be at least 1.8m - 3.0m wide or greater to meet the desired level of service in areas with higher pedestrian volumes, so as to allow pedestrians to walk side by side or for pedestrians going in the opposite direction to pass each other (Boodlal, 2003). Moreover, the walking zone should not be less than 1.2m, which is the minimum width required for people with disabilities (e.g. those using a guide dog, crutches, and walkers), and wheelchair users need about 1.5m to turn around and 1.8m to pass other wheelchairs (Boodlal, 2003). The width of the walking zone found on the campus is in the range of 1.5m to 3.6m but the average width is 1.6m.

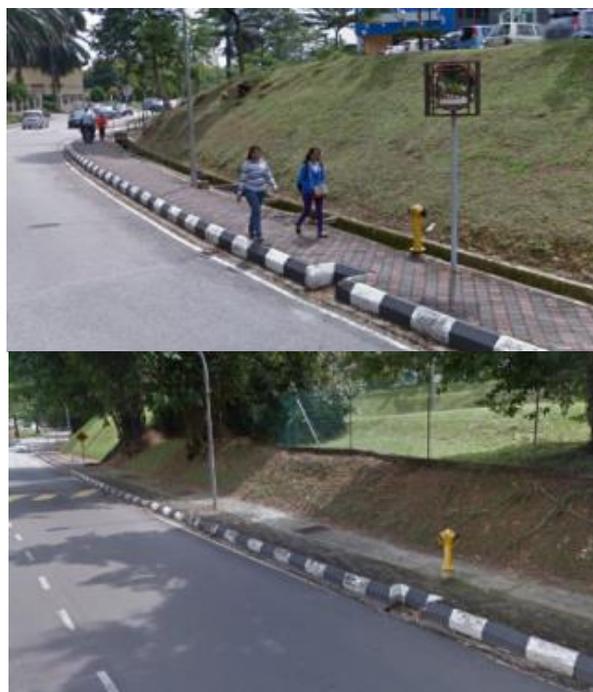
Figure 5: The sidewalk in front of Faculty of Built Environment (above) and the sidewalk outside of Second Residential College (below).

According to Boodlal (2003), a utility zone provides a buffer from the traffic zone and allows for the consolidation of elements like utilities (poles, hydrants, telephone kiosks, etc.) and street furniture (benches, signs, etc.), and although there is no specific or minimum width of utility zone mentioned, 1.2m is preferred. During our survey, we found that in certain areas on campus, the

utility zone and the walking zone were combined as one and this had created the obstruction for the pedestrian travel (Figure 5).

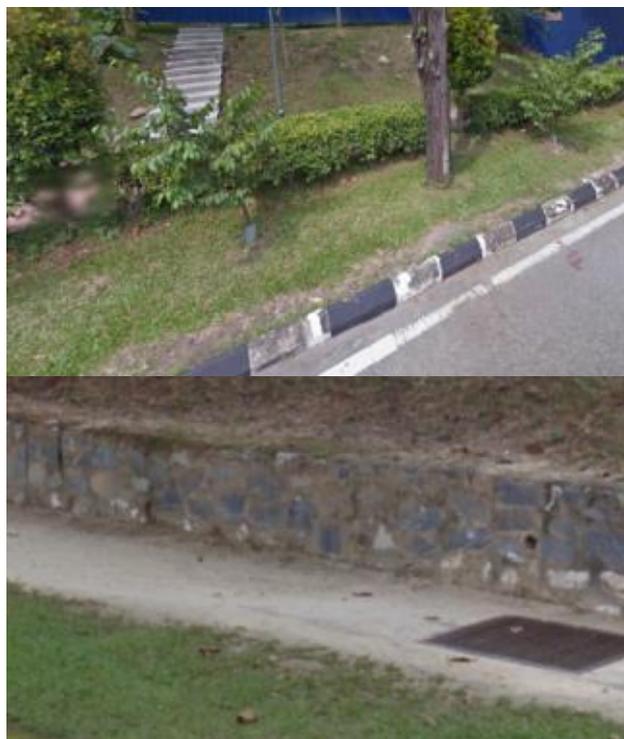
A pedestrian walking experience can also be improved by the presence of shade and visual aesthetics as provided by vegetation (trees and shrubs), which can also act as auditory buffer between pedestrians and the traffic (Figure 6). However, vegetation causes sidewalk cracks and changes in level (i.e. the vertical rises between adjacent surfaces), which could pose difficulty for persons with disability to lift their feet or crutches. Moreover, it is difficult for wheelchair users to roll over large changes in elevation. Low hanging branches also pose a safety hazard, especially for pedestrians with vision impairments who may not detect them and other pedestrians with mobility impairments may have difficulty bending under them. Therefore, careful selections of tree type, their placement and maintenance will provide a comfortable and safe walking environment.

Figure 6: Landscape zone (in front of walking zone) near the Center of Foundation Studies in Science (above) and the concrete sidewalk with manhole (below).

At UM, a common feature of sidewalks built above drainage is the presence of manholes for maintenance purpose (Figure 6). These manholes are a problem unto themselves if and when pedestrians dropped their keys and hand

phones through the grating into the manholes, whilst manholes that are not properly covered / maintained pose hazards to especially pedestrians with walking aids or in wheelchairs. It is recommended that sidewalk pavements (made using concrete, tarmac etc.) need to be slip-resistant and visually contrasting. Surfaces that are not slip resistant are especially difficult for people who use wheelchairs or walking aids to travel across. For example, crutch users rely on being able to securely plant their crutch tip to travel effectively on the sidewalk. Besides that, surfaces that are not visually contrasting (all one colour and texture) can make it difficult for pedestrians with vision disabilities to distinguish the difference between a change in colour and pattern on the sidewalk.
