## **TECHNICAL NOTE**

### **ENGINEERING GEOLOGICAL OF AN ACTIVE SLOPE IN KM46 SIMPANG PULAI, PERAK**

**Zainuddin Md Yusoff\*, Nur Anati Azmi, Haslinda Nahazanan, Nik  
Norsyahariati Nik Daud & Azlan Abd Aziz**

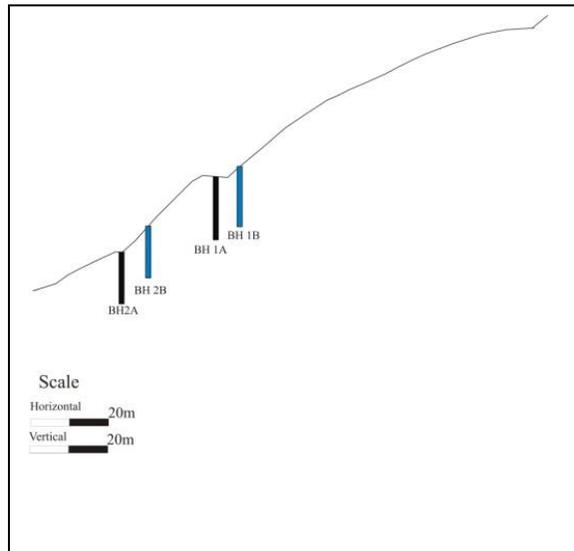
Figure 5: Four boreholes position

Subsoil investigation works were conducted to understand the factors that might contribute to the slope movement. The soil investigation involved four boreholes with Standard Penetration Test (SPT) and wash borehole drilled to the hard layer. Fig.5 shows the position of four boreholes at different levels with respect to the road level. Borehole 2A and 2B were drilled 70m from the road meanwhile borehole 1A and 1B were drilled 124m from road and 54m from borehole 2A and 2B.

A hard layer is defined as SPT  $N=50$  blows. In borehole 1A, the hard layer was encountered at 15m below ground level, 15.5m for borehole 1B, 15m for borehole 2A and 13.5m for borehole 2B. The holes were terminated after 3 times  $N=50$  blows which represents 4.5m thick hard layers. From the laboratory test, the materials forming the residual soils are sandy SILT to silty SAND. Three units type of soil were recognized as distinct geotechnical units which were sandy silt, very silty very gravelly sand and fragments of schist. The sandy silt unit consists of light grayish, dark yellowish, light yellowish to dark brownish colour with mixtures of sand and silt. The SPT value range from  $N=5$  to 50. The hardness varied from very soft to hard. The percentage of silt was more than 50% and sand is 20% to 35%. The very silty very gravelly sand unit varied from dark grayish to dark brownish colour. This unit composes mixture of sand, silt and gravel. The average composition for this unit was more than 50% is sand, 20% to 35% is silt and another percentage was gravel. The hardness of this unit was from very loose to very dense. Cross section from boreholes results (Fig.6) shows there were movement in BH2A and BH2B and this situation can be classified as shear zone. This showed that there was deep seated movement at great depths. However, the movement was very slow and will increase during rainy seasons. Another factor identified from the profile (Fig.6) was the existence of schist fragments that contribute to the infiltration of water, thus, allow rapid rate of weathering and produce unstable materials.
