A FIELD STUDY OF INDOOR AIR QUALITY IN A TROPICAL REFECTORY

Qi Jie Kwong, Farah Yasmin Sulaiman, Mohamad Sufian Hasim
Faculty of Architecture, Planning & Surveying,
Universiti Teknologi MARA, Shah Alam, Selangor, Malaysia.
kwong.qjie@mail.com

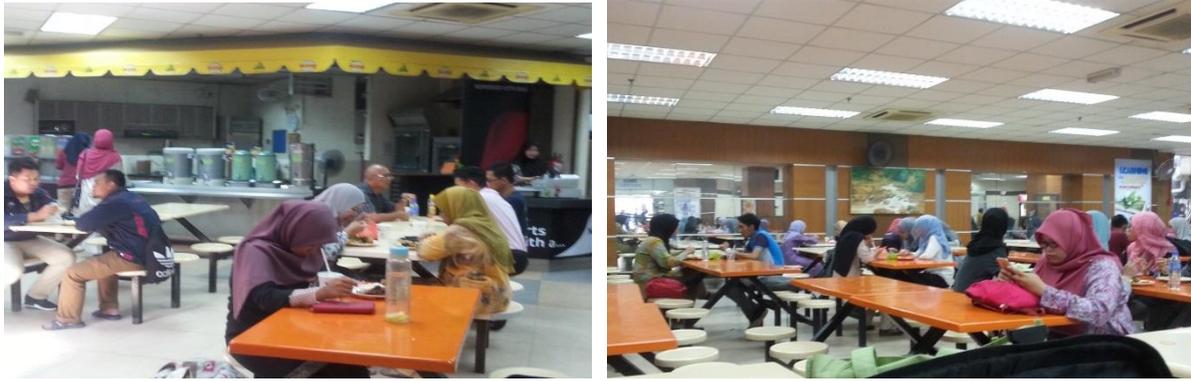
The selected refectory is a part of the administrative building of a local university, which is conveniently sited at the heart of the campus. It provides a diverse catering service to over 200 students and staff at one time. The building layout is a multi-concept plan and is divided into two sections – the air-conditioned indoor area where the kitchen, food serving stations and eating areas were located and the naturally ventilated outdoor space where independent stalls were set up. The main area of the building is concentrated on the right side, which is the indoor section. The dining area consists of both indoor and outdoor areas, circulating the row of food stalls and catering serving counters. Other services like cleaning and kitchen are placed indoors. The semester opening hours of the refectory are from 8.00 am to 5.00 pm and served breakfast, lunch and evening meals. The main entrance is located at the right side of the building. Besides, there are two sub-entrances located between the indoor and outdoor sections of the building, but only one is accessible. Although ceiling mounted air conditioners are available in the refectory, not all units are switched on during the air sampling period. Three windows are located near to the entrance doors and were kept closed throughout the field survey due to the use of air conditioners. The indoor environment of the refectory is shown in Figure 1. Since this academic institution is a public one, smoking within its compound is strictly prohibited.

Figure 1: Indoor environment of the refectory under study
